**APPENDIX I**  
**ENVIRONMENTAL EVALUATION –**  
**STADIUM PARKING**

# **Environmental Evaluation – Stadium Parking Rentschler Field Redevelopment Project East Hartford, Connecticut**

July 2006

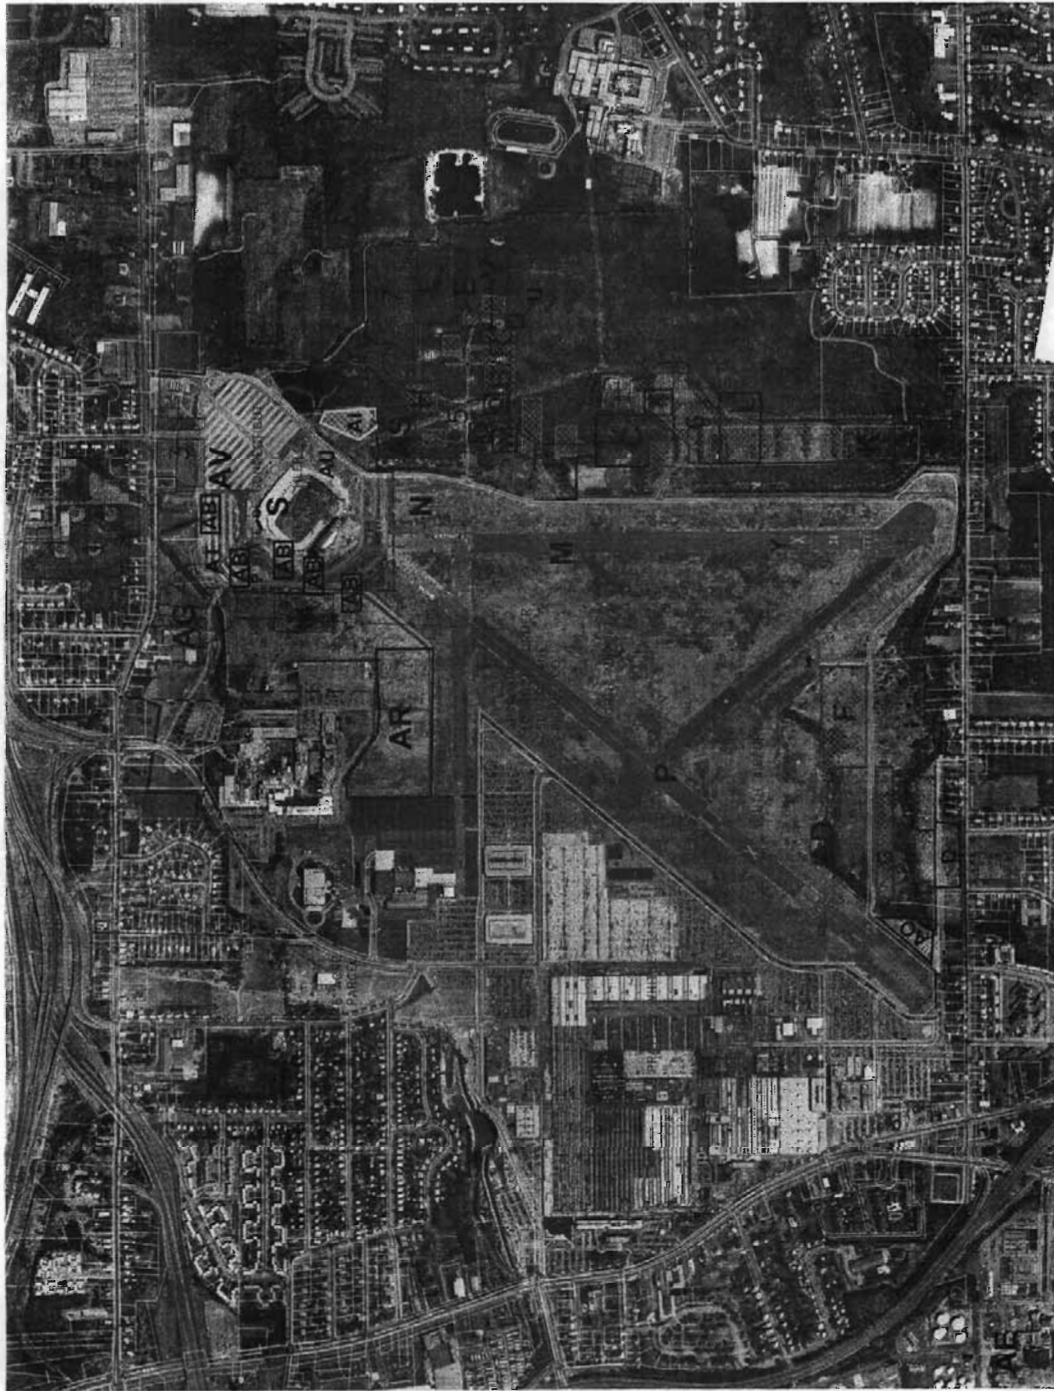
- POSSIBLE STADIUM PARKING AREA WITH OVL
- APPROXIMATE LIMITS OF RECOGNIZED ENVIRONMENTAL CONDITION (AR) (PHASE 1 ENVIRONMENTAL SITE ASSESSMENT)
- ELUV REFERENCED IN TOWN AND STATE RECORDS
- PROPOSED ENVIRONMENTAL LAND USE RESTRICTION (P) (PHASE 1 ENVIRONMENTAL SITE ASSESSMENT)
- GENERAL AREA OF RECOGNIZED ENVIRONMENTAL CONDITION (P) (PHASE 1 ENVIRONMENTAL SITE ASSESSMENT)
- PHASE 1 SITE BOUNDARY
- UTC PROPERTY BOUNDARY
- STATE PROPERTY BOUNDARY

1. BASE MAP PROVIDED BY BAYSTATE ENVIRONMENTAL
2. ALL INFO APPROXIMATED BASED ON INFORMATION PROVIDED BY FUS & O'NEILL AND LOUISER ENGINEERING ASSOCIATES (LEA)
3. PROPOSED ELUV AREAS OBTAINED FROM FUS & O'NEILL MAP ENTITLED "EXISTING CONDITIONS PLAN" DATED MARCH, 2006.

Figure 1 Site Location Map
Figure 2 Site Plan
